Manhole Inspection Summary

Manhole # S17AA1004MH

Insp Date: **2/28/07 9:14 AM**

Location Address: **2281 PARK HILL AVE**

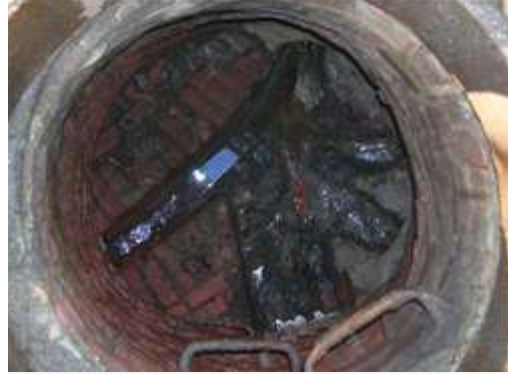
Top View

Corroded steps. Evidence of surcharge - Bench debris. Channel debris.

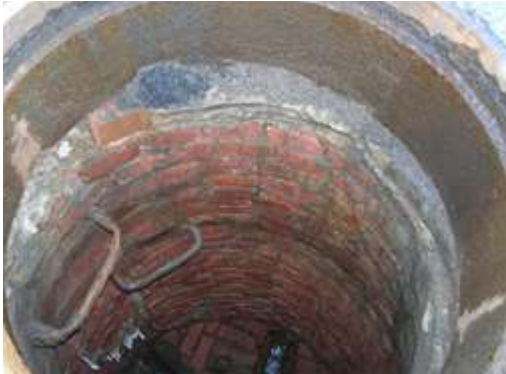
Defect

Frame leaks. Frame offset. Adjustment deterioration and infiltration. Corbel and Barrel infiltration - other side.

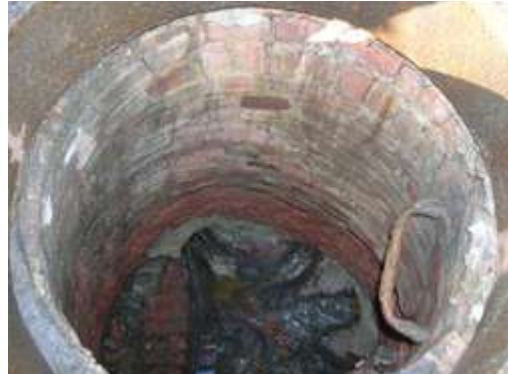
Defect

Frame leaks. Frame offset. Adjustment deterioration and infiltration. Corbel and Barrel infiltration - other side.

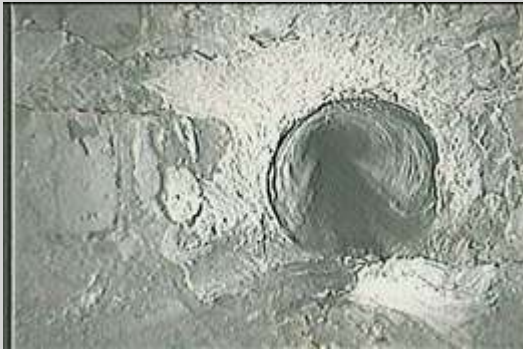
8 in. Circular Gravity Sewer Pipe Out @ 12 O'Clock

Infiltration: **None** Pipe Seal Cond: **Cracked**

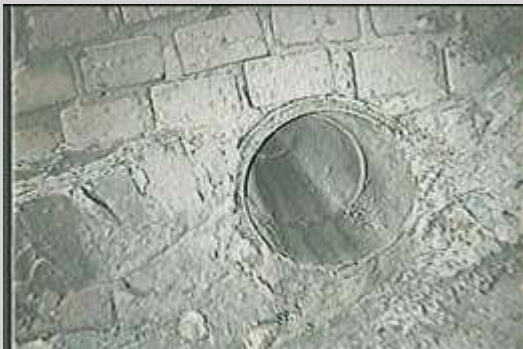
8 in. Circular Gravity Sewer Pipe In @ 3 O'Clock

Channel deterioration.

Infiltration: **Evidence** Pipe Seal Cond: **Unknown**

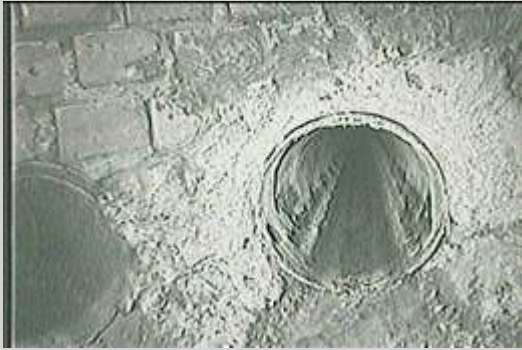
Pipe In @ 4 O'Clock

Barrel deterioration and infiltration.

Deposits: ☐ None ☐ Mud ☐ Sludge ☐ Debris ☒ Grease

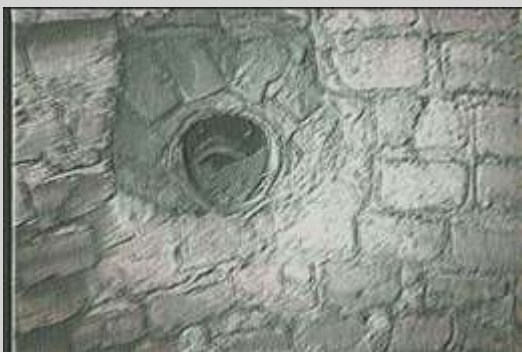
Pipe In @ 5 O'Clock

Infiltration: **Evidence**

Pipe Seal Cond: **Cracked**

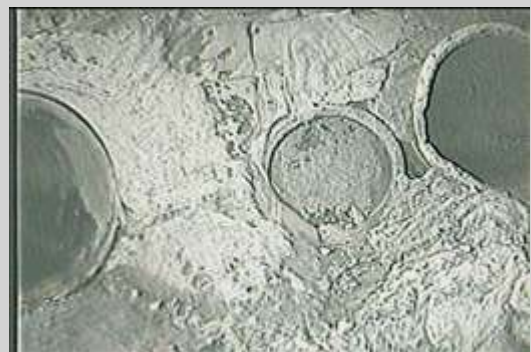
Drop In @ 5 O'Clock

Drop Condition: **Clogged**

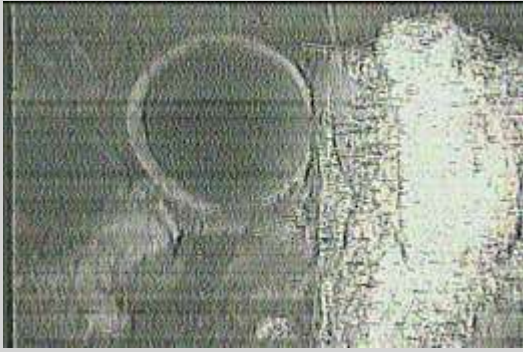
Pipe In @ 6 O'Clock

Infiltration: **Evidence** Pipe Seal Cond: **Unknown**

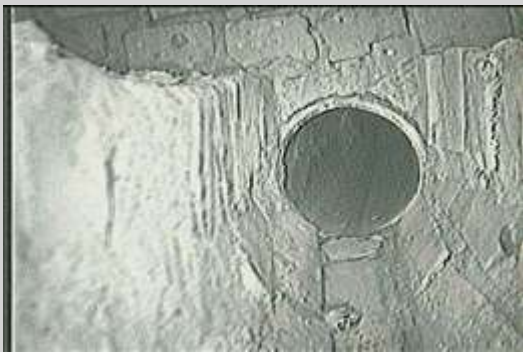
Pipe In @ 8 O'Clock

Infiltration: **Evidence** Pipe Seal Cond: **Unknown**
